## **LIFE EXTENSION OF NELSON RIVER HVDC SYSTEM**

**N.S.DHALIWAL\* J.R.MCNICHOL, R.A.VALIQUETTE**  
**Manitoba Hydro**  
**Winnipeg**  
**Canada**

### **SUMMARY**

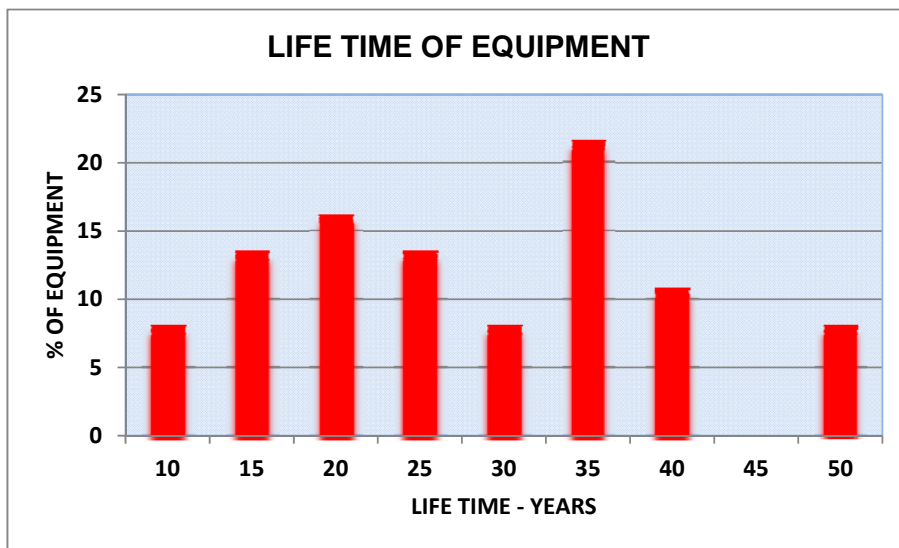
Figure 2 – Expected Life Time of Various HVDC Components

An EPRI report [3] on Life Extension of HVDC Systems provides a guide for the life time of various components of an HVDC system. Figure 2 shows the percentage of equipment with their expected life time as per [3]. In the figure 2, each component is treated as being the same regardless of the size of the equipment. For example, figure 2 shows that 16% of the components have a life time of 20 years and 14% of the components have life time of 25 years, etc.

It can be concluded from figure 2 that life extension measures start after 10-15 years of service and would continue to be required periodically throughout the life of the project.

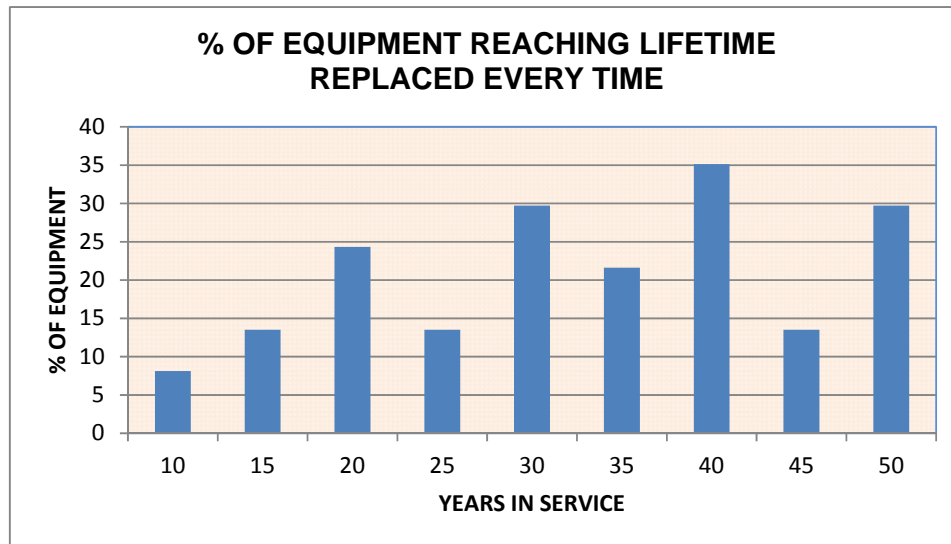
Figure 3 – Percentage of Equipment Replaced vs Years of Service

Figure 3 shows what percentage of the equipment would have to be replaced if the HVDC system was to operate for 50 years. It should be noted that during a span of 50 years some components with shorter life times (10-15 yrs) would be replaced more than once. Digital controls may fall into this category.

The increase in outage requirements for Nelson River Bipole 2 is consistent with what would be expected as per figure 3.
